TECHNICAL BULLETIN

T B 1 0 2 3 0 9

ATRO's UB20500 and New UB20500-OS in the Freightliner Air Liner II Suspension

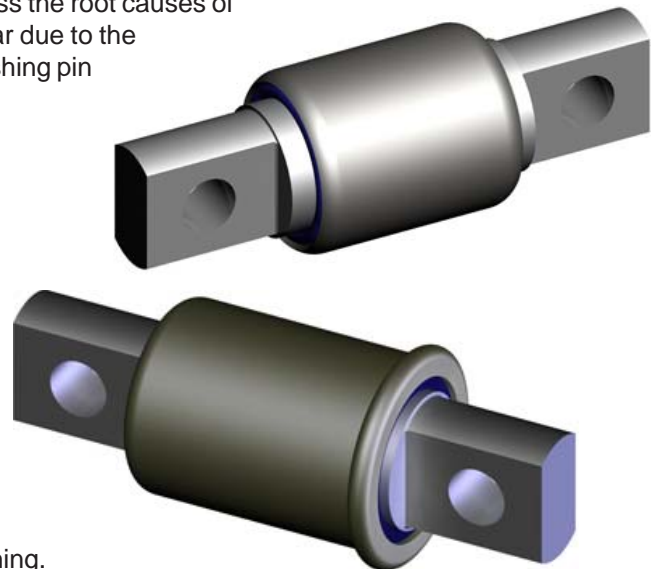
The OE *rubber* pivot bushing, RB205/RB234/RB268, for the Freightliner Airliner II suspension has had problems with the bushings rotating and migrating out of position within the eye of the spring. This was due to the spring eye weakening with stress and use causing the eye to open up beyond the OE specifications. As the eye of the spring gets larger, the grip on the bushing gets correspondingly weaker and the bushing will begin to rotate and walk out of position. The most recent OE *rubber* bushing design, the RB268, is crimped (one end) with the opposite end flared to prevent the bushing from migrating out of the spring when the eye begins to weaken. However, this OE rubber bushing does not address the root causes of the problem. The stress put on the spring eye and the wear due to the suspension articulation and the non-rotating OE rubber bushing pin results in the entire bushing rotating and laterally walking (migrating) out of position.

UB20500 with our original unique rotating pin design, if the spring is not worn out and the eye has not already been enlarged, the outer sleeve of the bushing will stay securely in place while only the pin rotates within the body of the bushing. (ATRO's UB20500 bushing only requires approximately 25 - 40 ft. lbs. of torque to rotate the pin.)

NEW UB20500-OS – our unique rotating pin design, oversized, anti-walk bushing. This bushing is .060" oversized and takes up the gap in most enlarged eyes. ATRO is offering a one-year warranty on the oversized bushing.
